# Seawall Manual

**City  
of  
Belleair Beach**

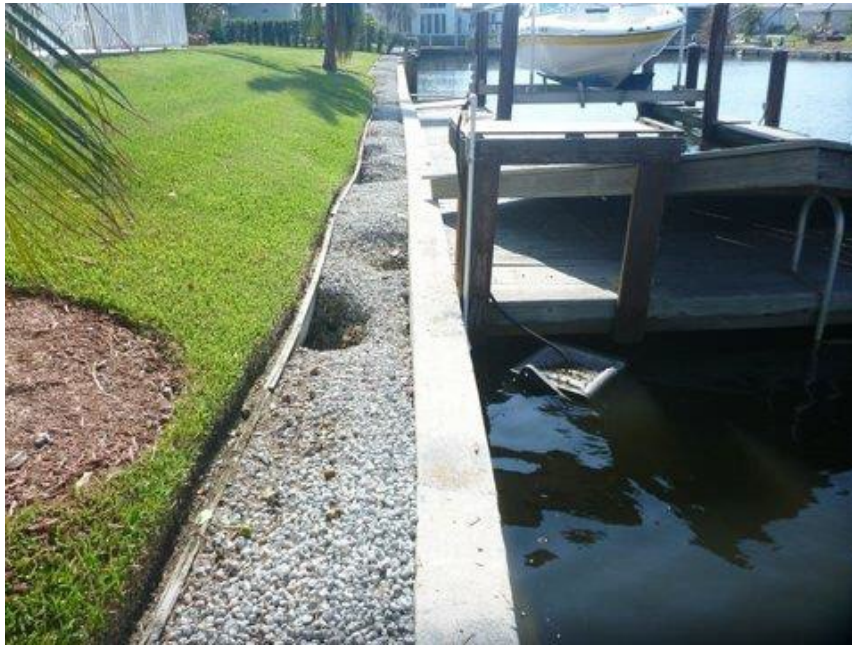
### **SINKHOLES:**

**Symptoms:** Sinkholes upland of the wall, visible back-fill mounds in the water near seawall joints (most visible at low tide)

**Cause:** Age, settling, structural failure, insufficient berm at the slab toe of the wall. Slab separation allowing backfill to migrate through openings into the water. Frequently occur after heavy rains.

**Remedies:** Replenish or add rock to the French Drains if fill loss is excessive. Installation of a French Drain may be appropriate if not already present. Maintain water passage through weep holes by cleaning or add supplemental drainage. Add filter fabric to vertical slab joints. If berm is lacking at the slab bottoms, may require replenishment.

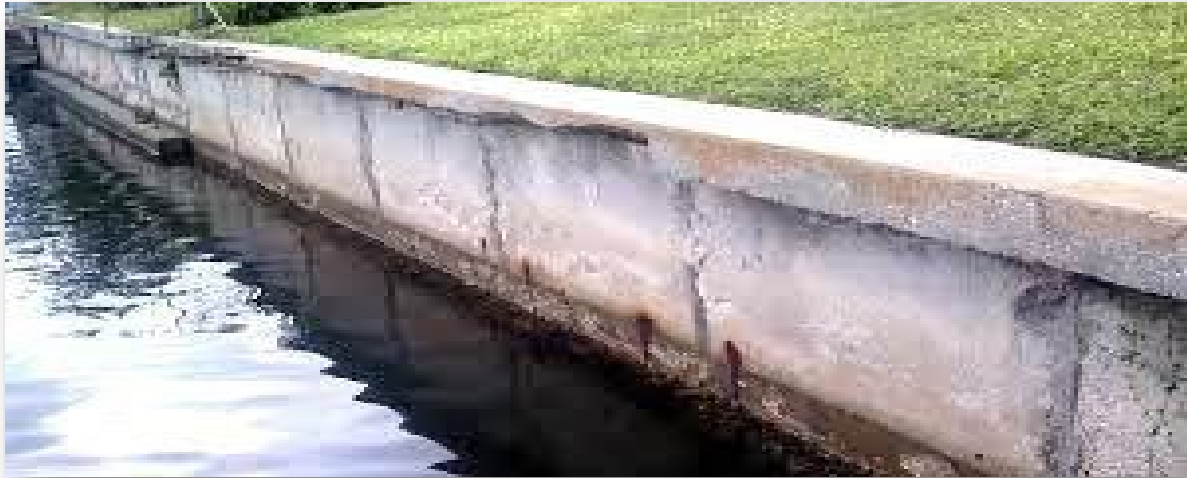
## CAP FAILURE

**Symptoms:** The principal symptom is rust, spalling, exposed rebar, fractures.

**Cause:** Aging, corrosion of concrete and reinforcing rod and uneven hydrostatic pressure. Slabs or panels develop horizontal cracks usually along the water line, and the panels eventually break along these lines.

**Remedies:** Partial or full cap replacement.

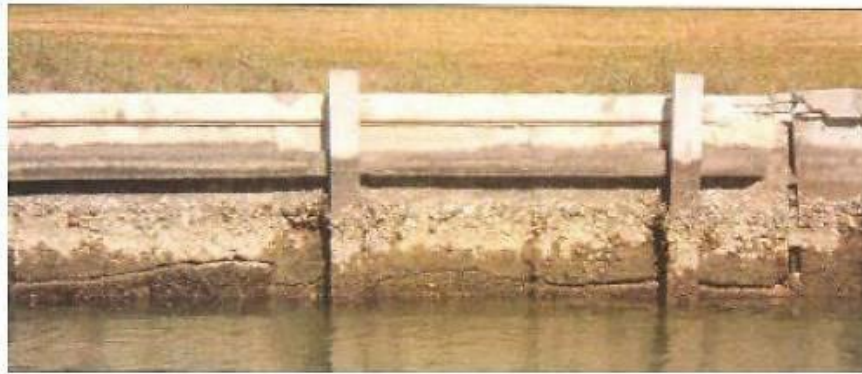
Note the horizontal crack just above the water line and the wide gap between slabs at the right. Concrete pilings have been driven to attempt to stabilize the wall.

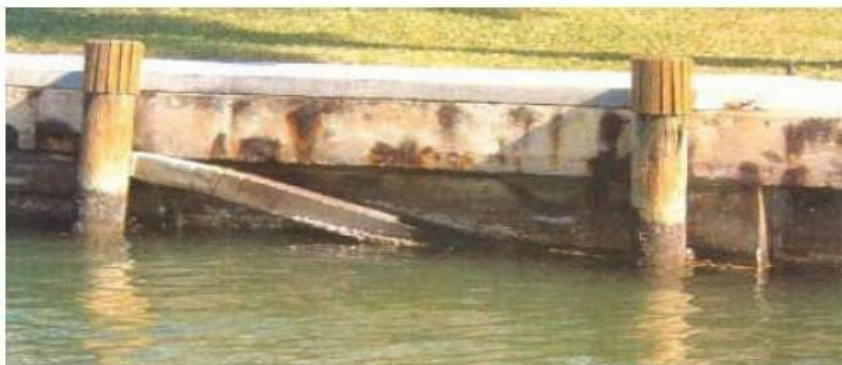
The tieback rods to the reinforced concrete waler have rusted through and the unsupported waler is useless and falling into the water.

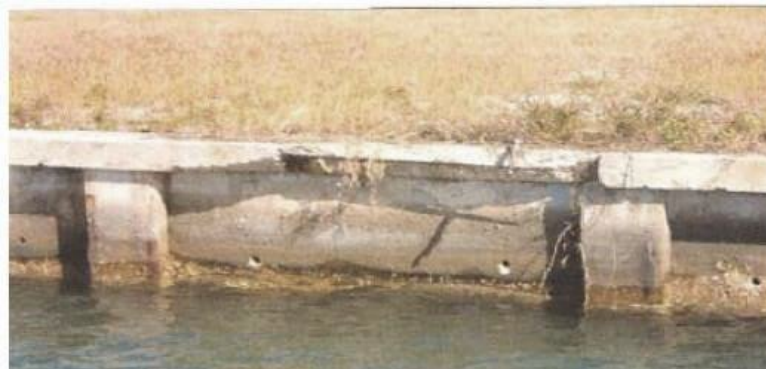
The concrete cap on this seawall has failed. As the cap comes apart, tie-back rods will have no anchor point. Without a solid cap there will be nothing to hold the vertical walls in alignment

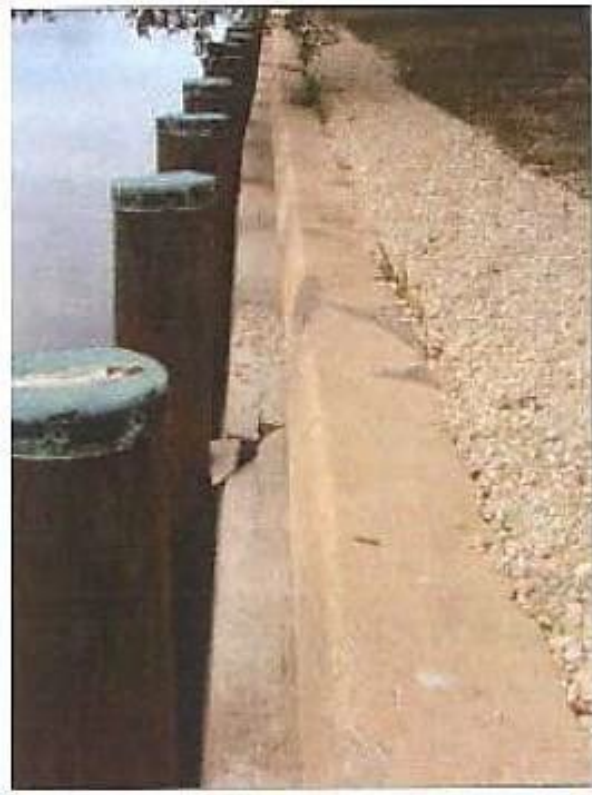
Note the back-leaning cap on this seawall. The berm has failed, and the toe has moved out toward the canal tipping the whole structure. The pilings are the only component retaining the toe of the wall. The concrete waler is also starting to fail.

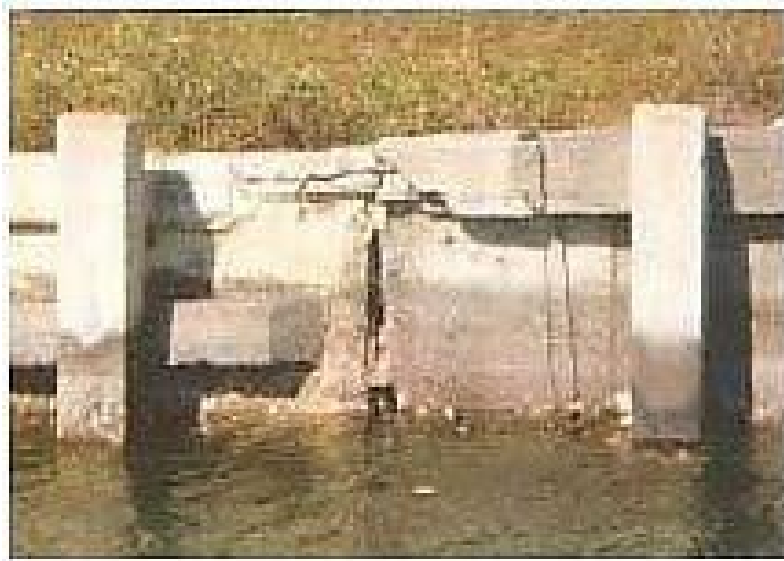
Note the extreme slab joint (seam) separation visible in this photograph taken at the property line. Rock and soil from behind the wall will be washed out from between the panels with wave and tidal action. Heavy rain will also contribute to erosion. Advanced cap deterioration is plainly visible. Concrete pilings have been placed in front of the waler to attempt stabilization.

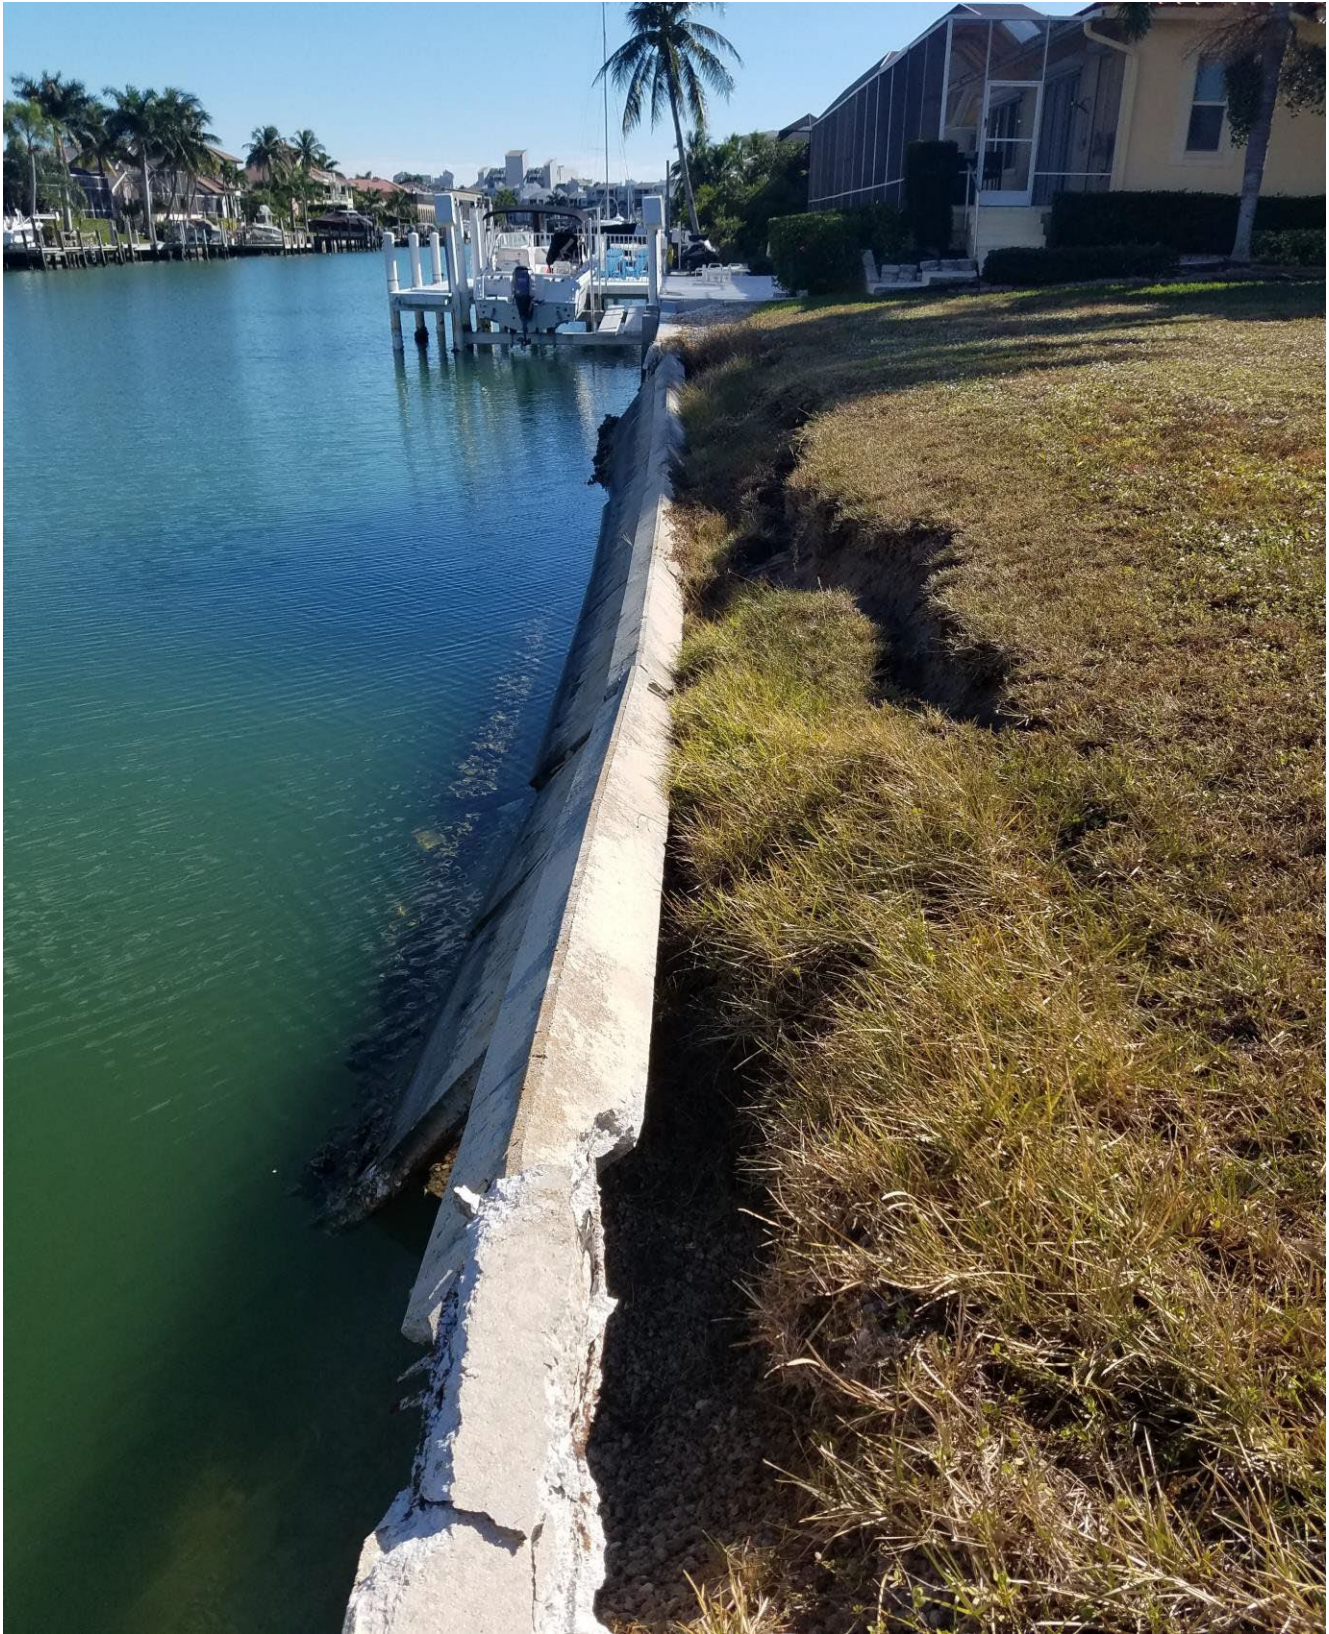
Berm failure (insufficient panel penetration during installation or scouring of berm due to tidal action) has caused the seawall to kick-out. Complete replacement of the seawall is necessary.

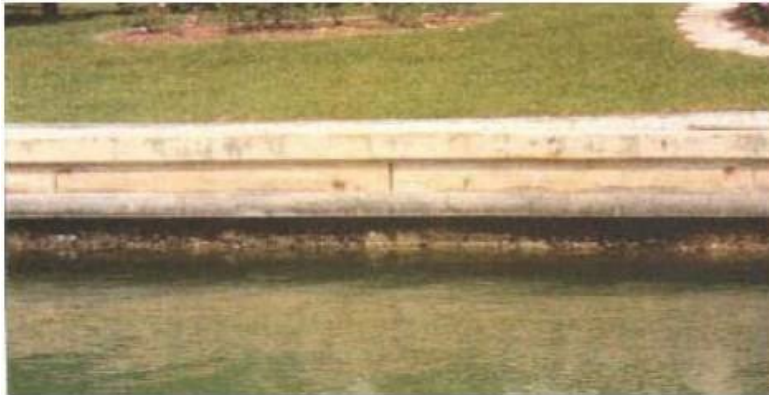
A waler is installed about 2 ft. below the seawall cap. The waler is a horizontally placed reinforced concrete beam which is connected to tie-back rods anchored to deadman. A waler is usually added as reinforcement when it is suspected that the original tie-back rods to the cap have rusted-through.

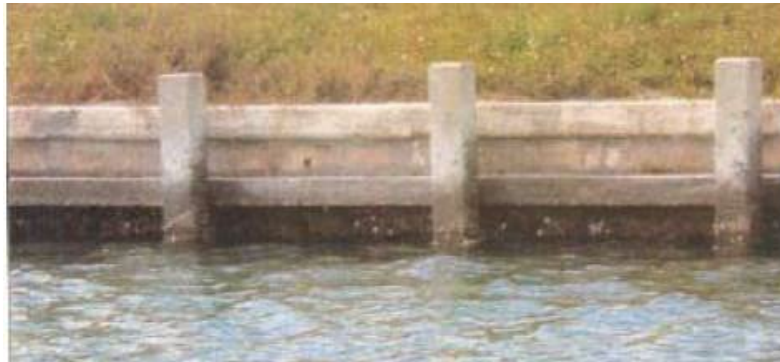
This seawall has a waler plus concrete pilings driven into the canal bottom for extra support. The pilings help stabilize the wall to keep the toe of the wall from moving out.

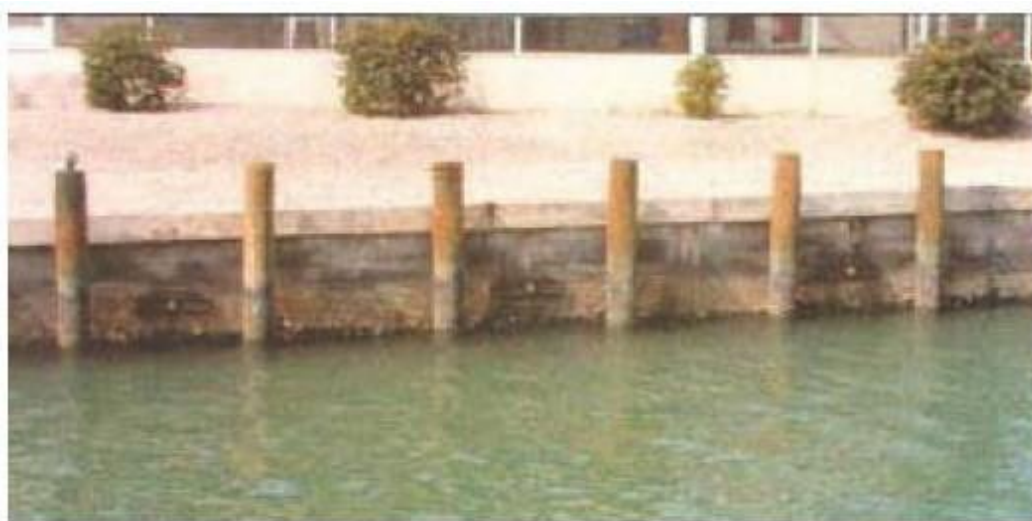
Wooden pilings are also used for stabilization. This seawall also has galvanized steel channels just above the water level which are anchored to the deadmen in the same manner as a waler.

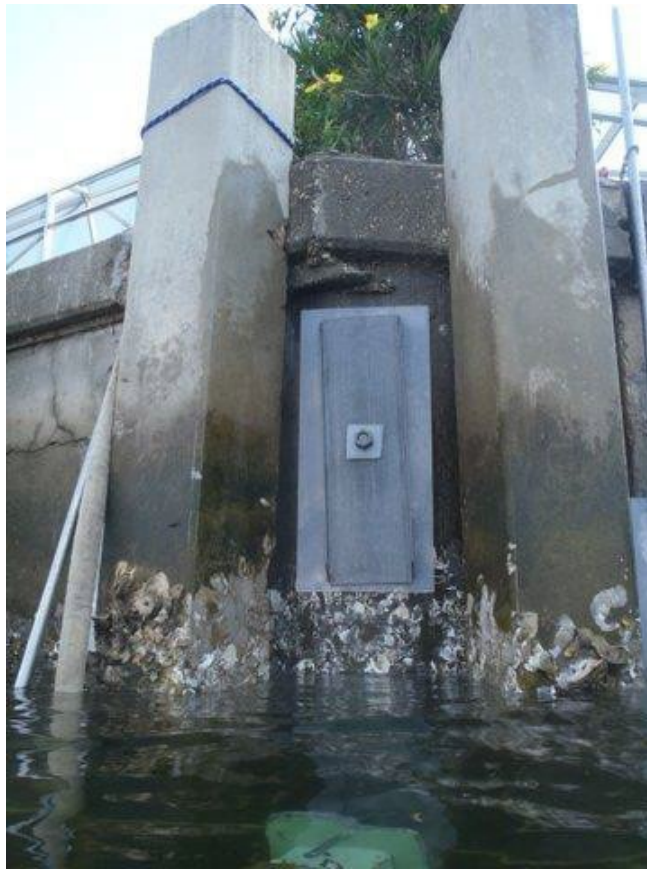
Supplemental tieback example – in this case, a helical tieback installed at corner point with vertical flange. The actual tieback is a solid rod with helices driven 14-21 feet into the ground at a specified angle.

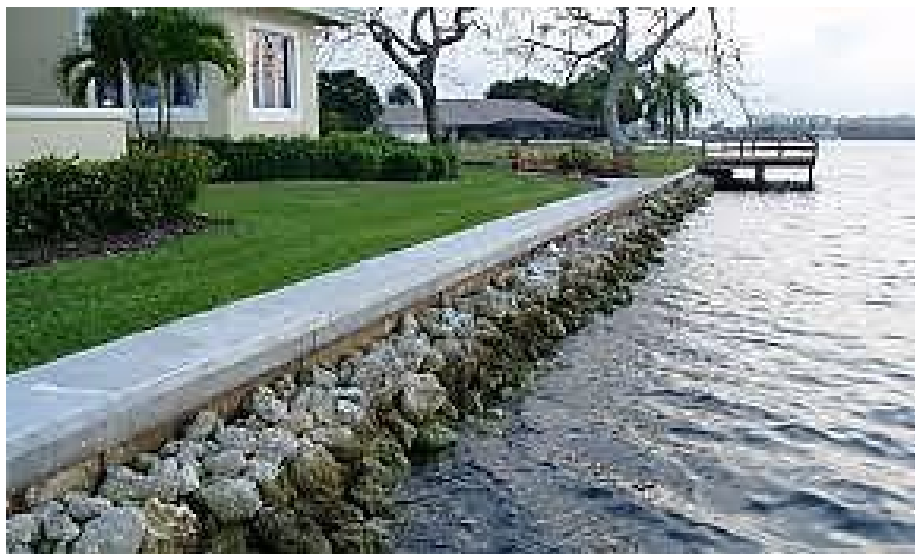
Rip-Rap (stone piled against the seawall) is particularly useful in areas of high tidal velocity to keep berm from washing away. Unfortunately, rip-rap can hamper boat docking and dock installation.

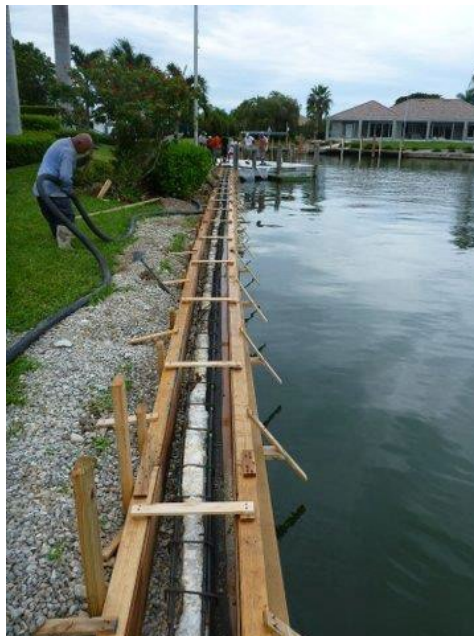
Framing and pouring of new (replacement) cap

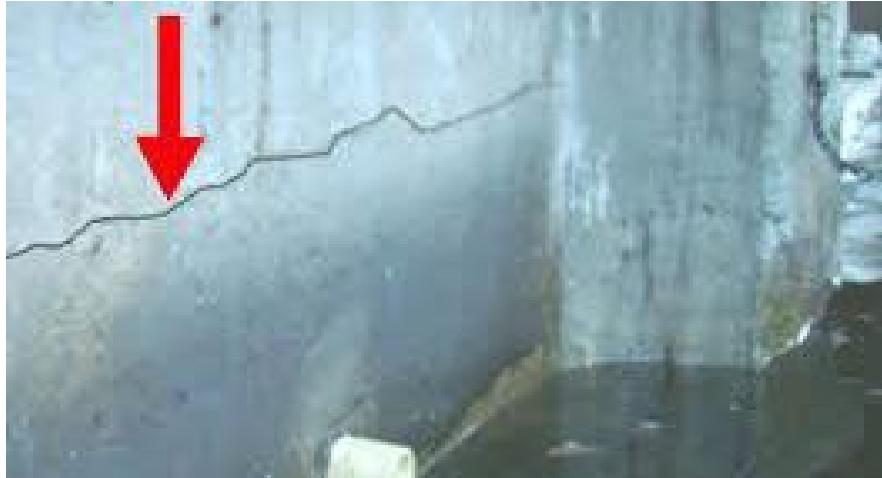
Note horizontal crack at mid-point of concrete panel – the weakest point of the seawall, particularly at low tide. Crack is likely caused by either excess hydrostatic pressure or possibly a tieback failure. Drain (bottom of picture) was likely installed in response.

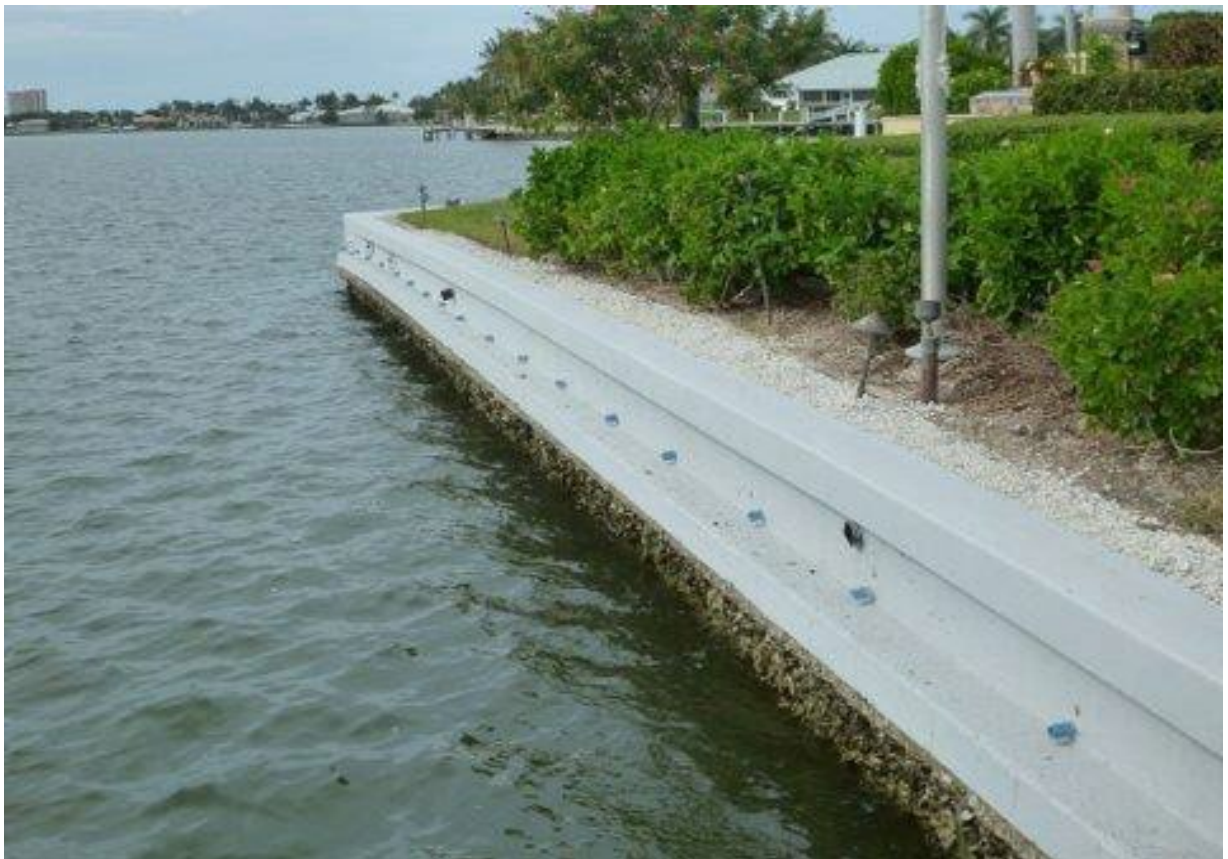
Supplemental drainage system designed to relieve hydrostatic pressure

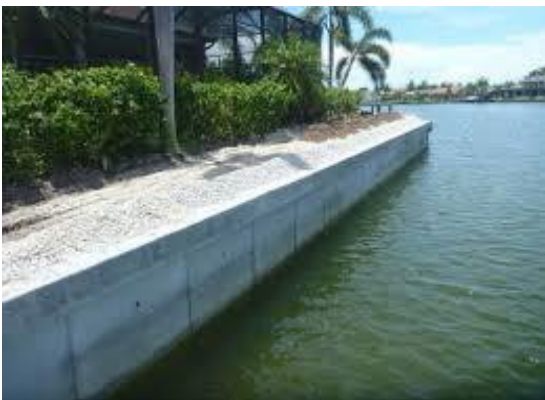
Concrete seawall

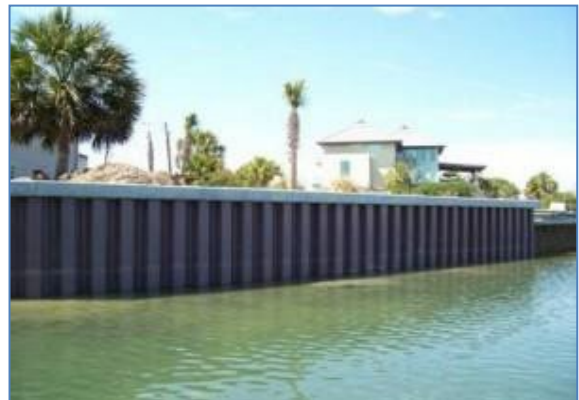
Vinyl Seawall with Concrete Cap
